**ELECTRIC DIVISION EVALUATION REPORT**

**ELECTRIC UTILITY RESPONSE TO THE WINTER FREEZE**

**OF DECEMBER 21 to DECEMBER 23, 1989**

**An Evaluation of the Actions Taken by Texas Utilities  
to Correct Technical Plant Equipment Problems**

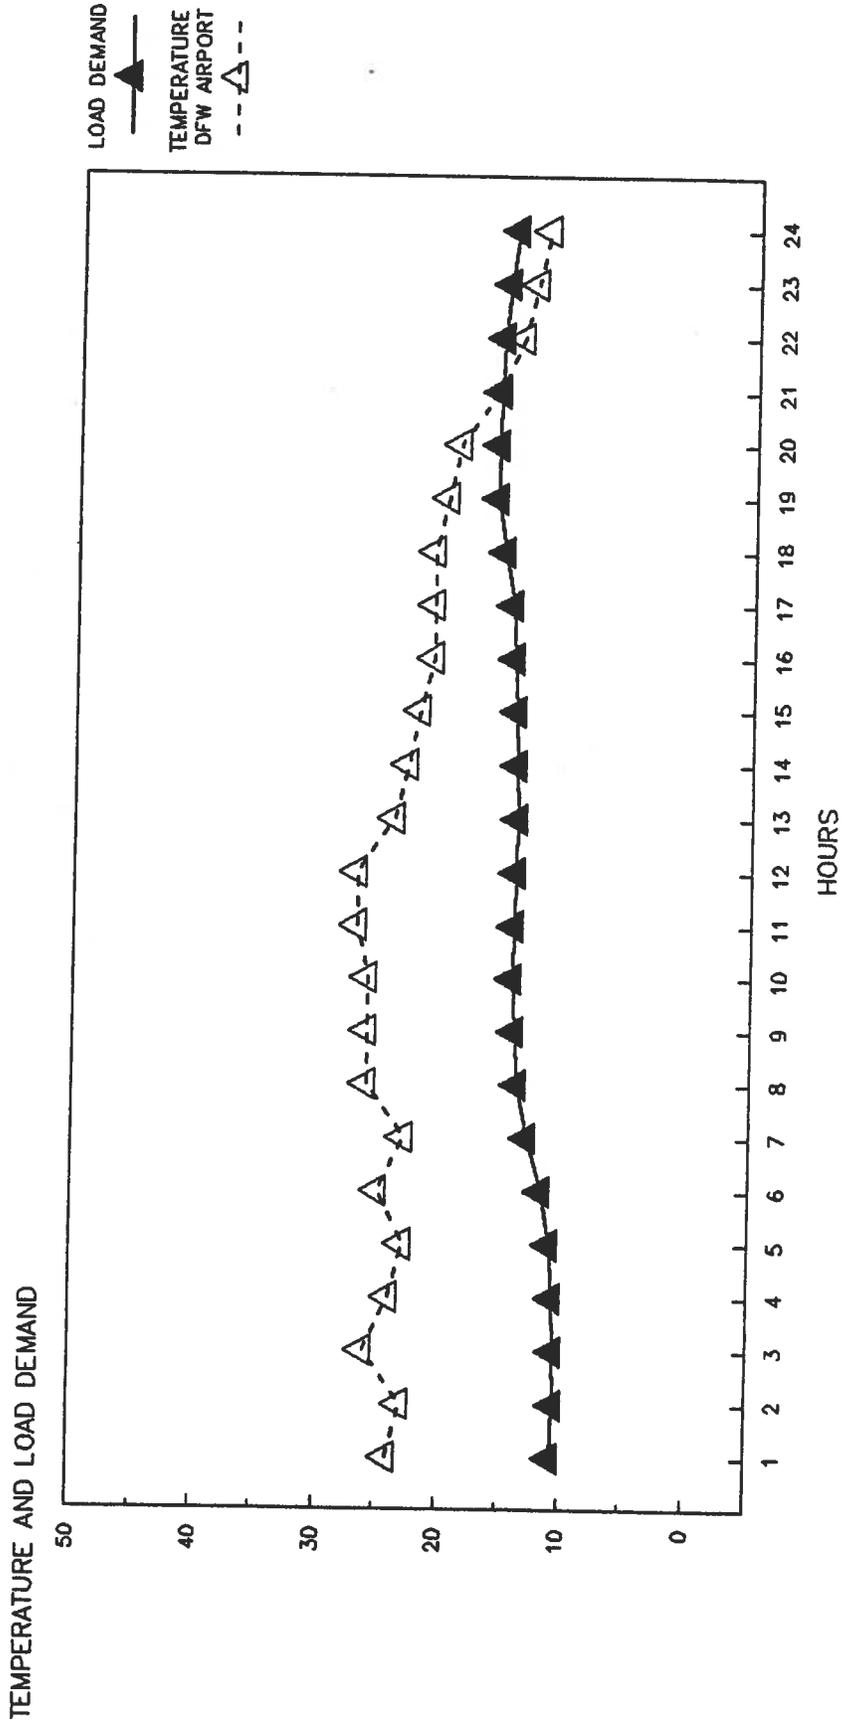
TEXAS UTILITIES ELECTRIC COMPANY  
LOAD TEMPERATURE VARIATION  
December 21, 1989

LOAD DEMAND IS x 1000.

**Temperature Variations December 1989**  
**Texas Utilities Electric Company,**  
**DFW Airport Temperatures**

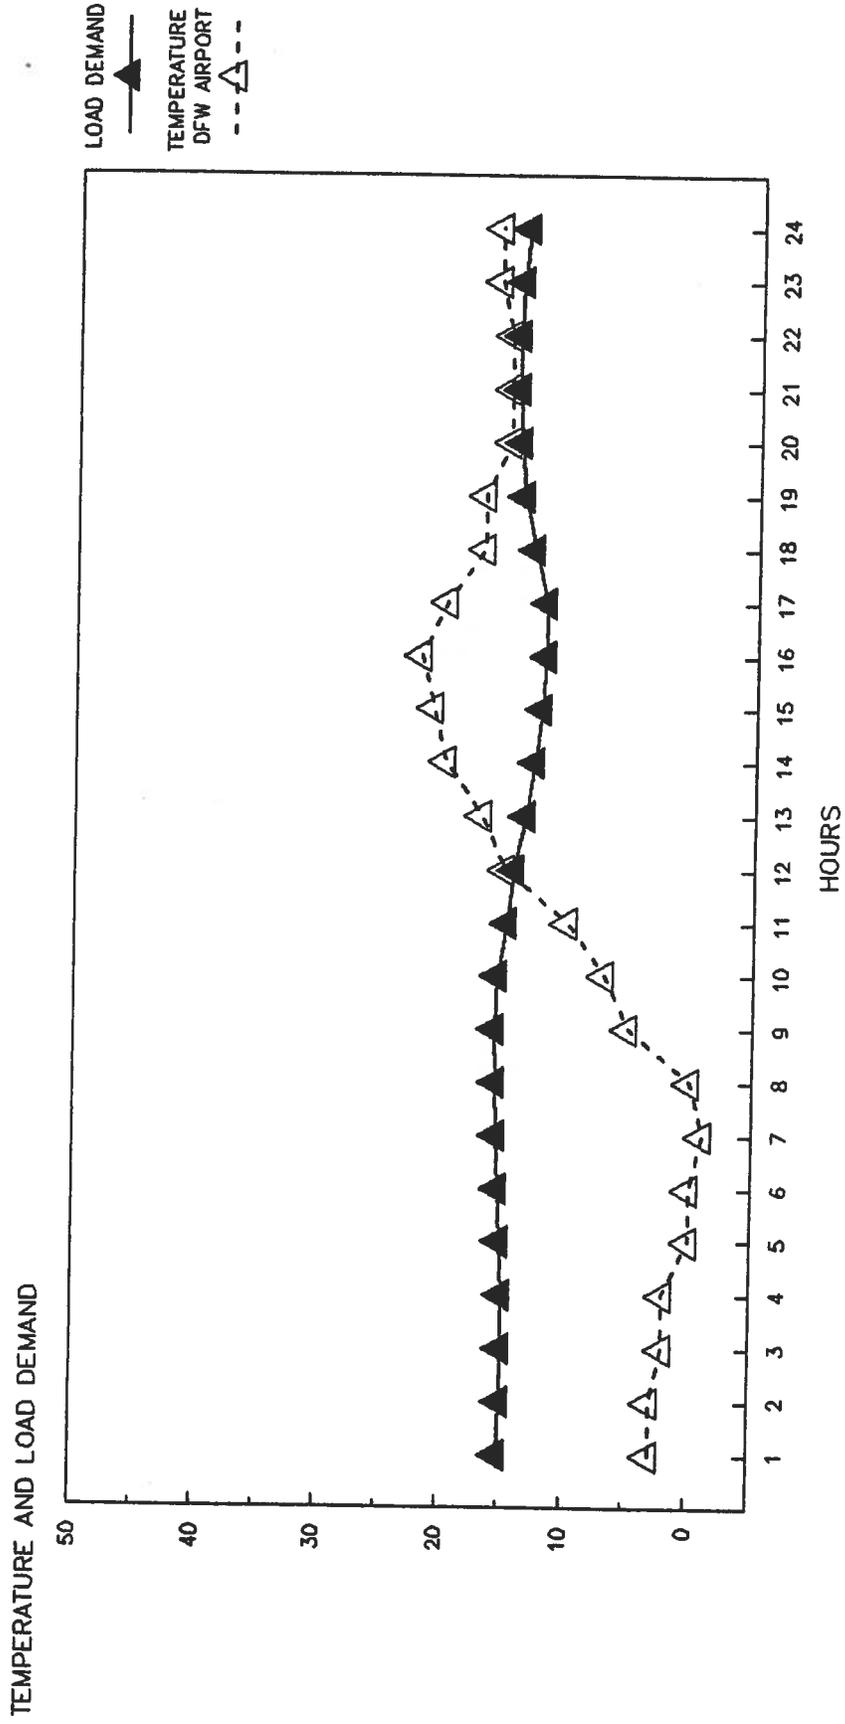
TEXAS UTILITIES ELECTRIC COMPANY  
LOAD TEMPERATURE VARIATION  
December 23, 1989

LOAD DEMAND IS x 1000.

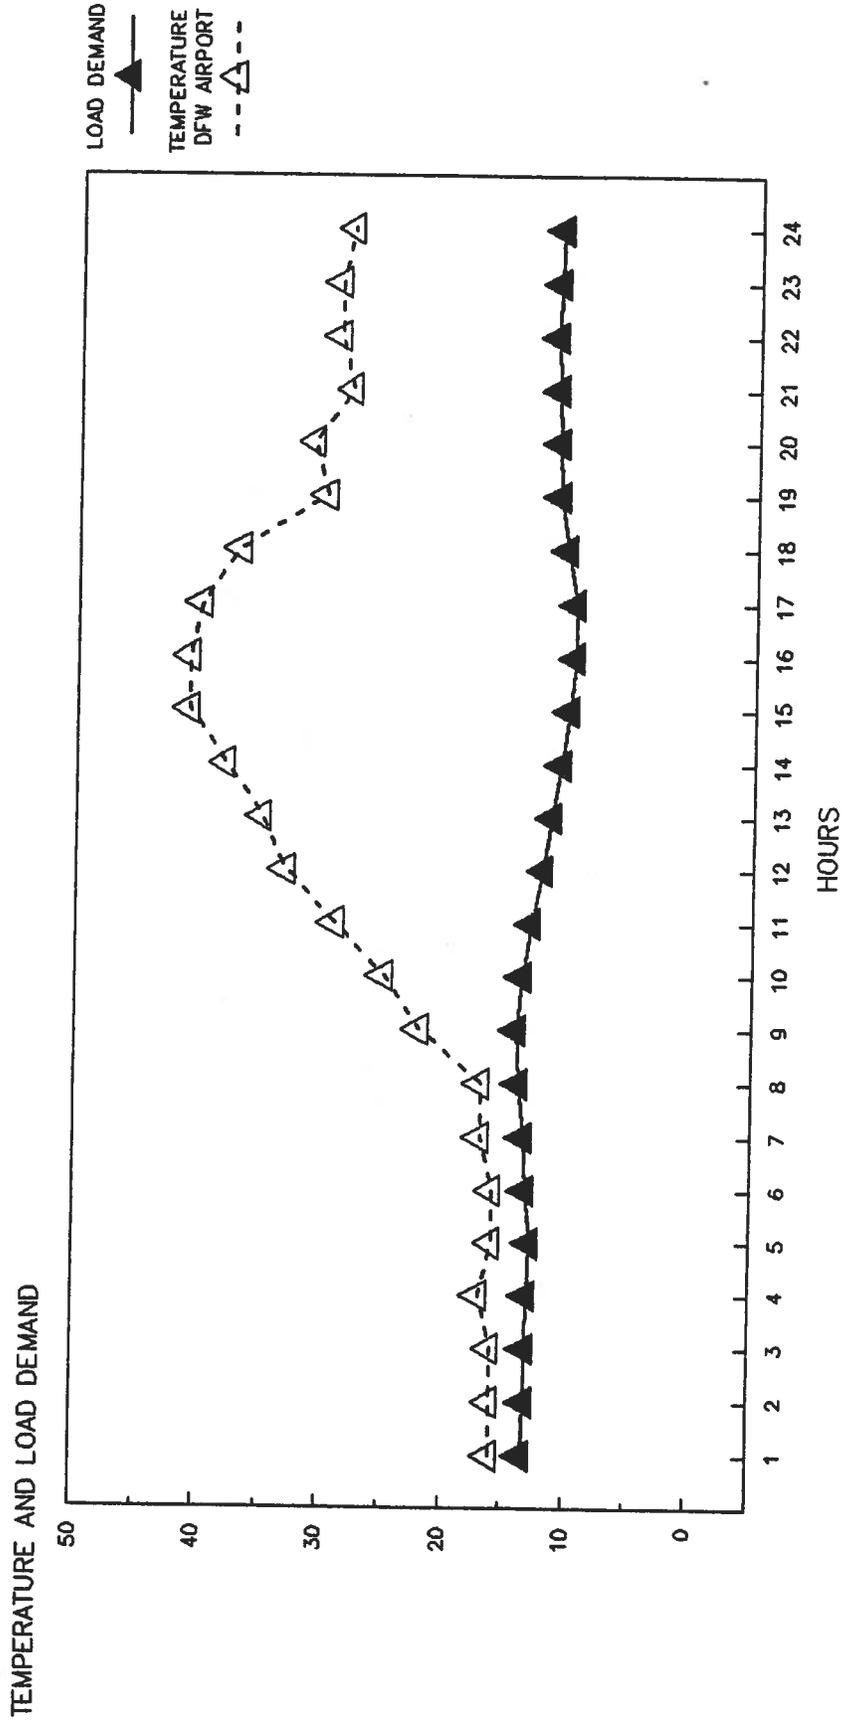
TEXAS UTILITIES ELECTRIC COMPANY  
 LOAD TEMPERATURE VARIATION  
 December 24, 1989

LOAD DEMAND IS x 1000.

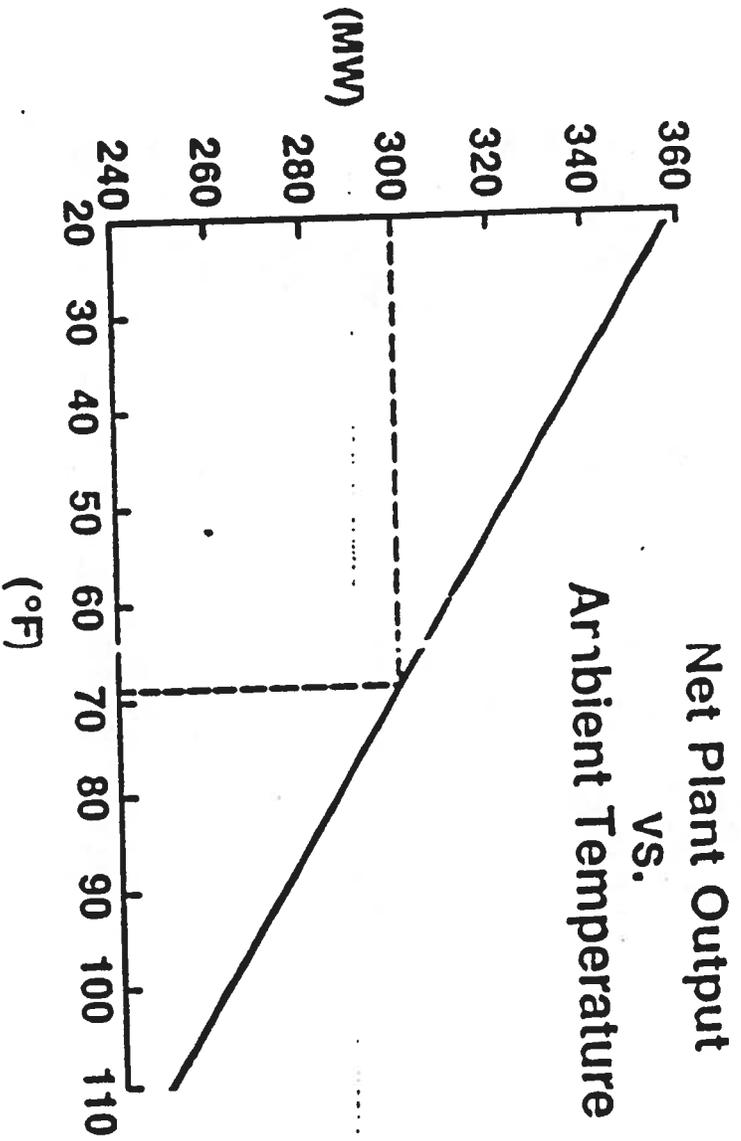
**Sensitivity to Inlet Temperature is Characteristic of Gas Turbine Cycles;**
